4.0 PHASE I ARCHAEOLOGY SURVEY WORK PLAN

Table 4.
Proposed Phase I Archaeology Survey of the School Bell Road Improvements Project APE

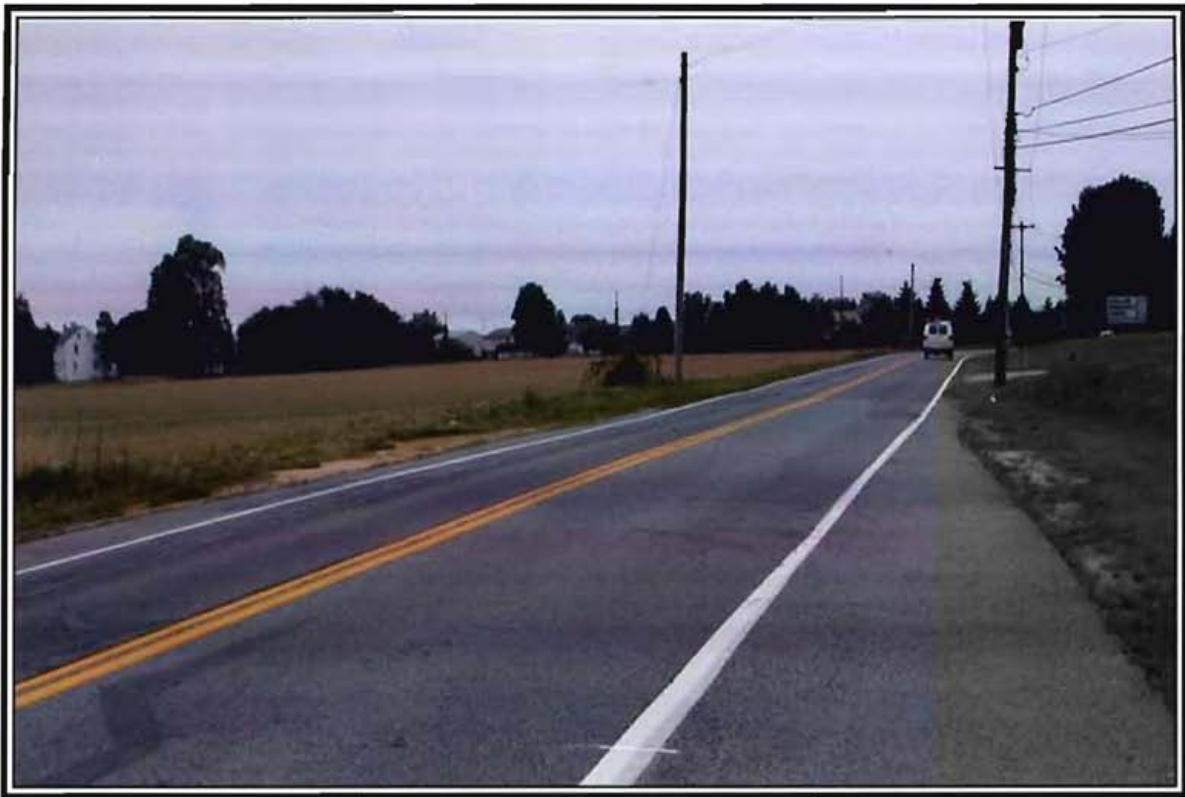
Photograph 1. View of Test Area 1, facing east-southeast.

Project APE Segment	Testing Methodology*	Expected Resources	Justification
North Side of School Bell Road (west to east)			
A Stations 17+50 to 25+50	no testing	none	scalped and graded areas, paved driveways, previously excavated biofiltration swale, adjacent to existing roadway shoulder disturbance.
Test Area 1 (Photograph 1) Stations 25+50 to 29+75	12 STPs at 15.0 m intervals	pre-contact - isolates; small artifact scatters; temporary, single to multiple use sites historic - rural domestic artifact scatters	<i>in situ</i> soils of appropriate age; upland topographic setting; well drained soils (Matapeake silt loam); minor disturbance from existing roadway; minor erosion of Matapeake soils. no historic documentation of structures; rural land-use throughout historic period.
B Stations 29+75 to 51+75	no testing	none	paved driveways; extensive housing development with associated fencing, landscaping, and paving; excavated water retention area; ditches and subsurface road drainage structures; buried utilities; adjacent to existing roadway shoulder disturbance.

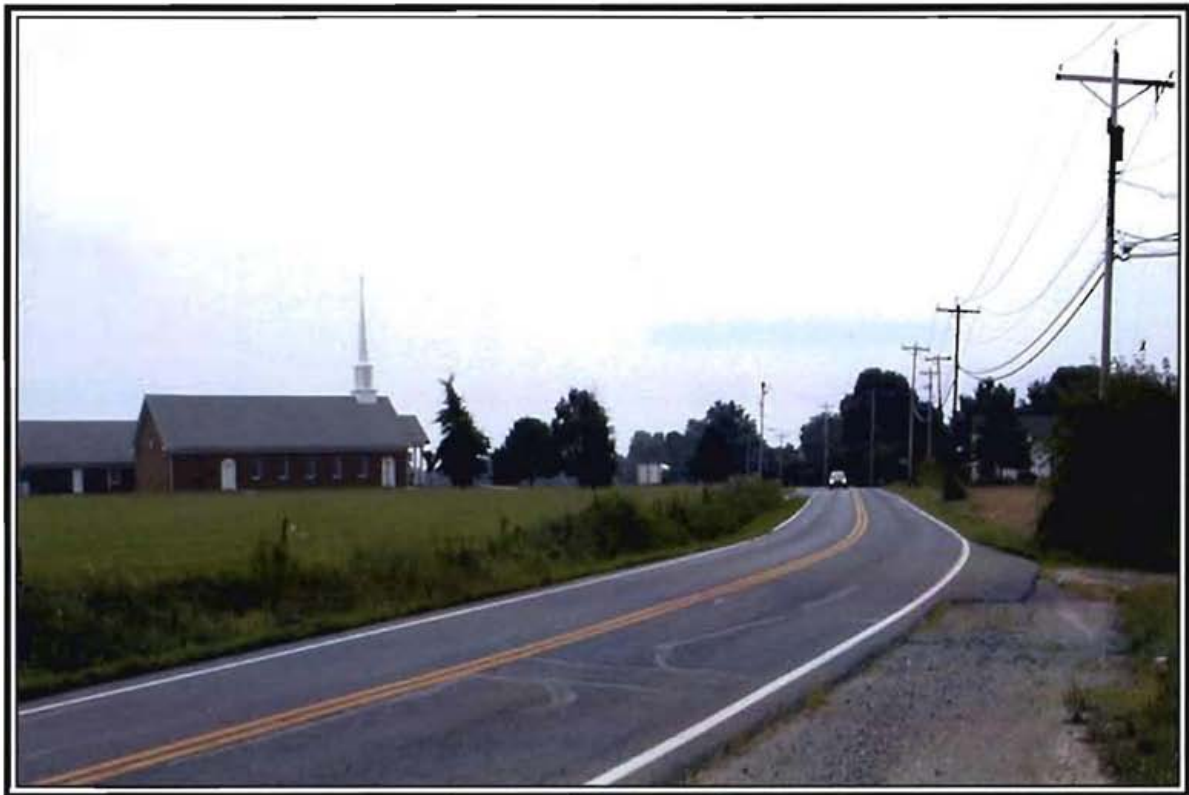
Photograph 2. View of Test Area 2, facing east.

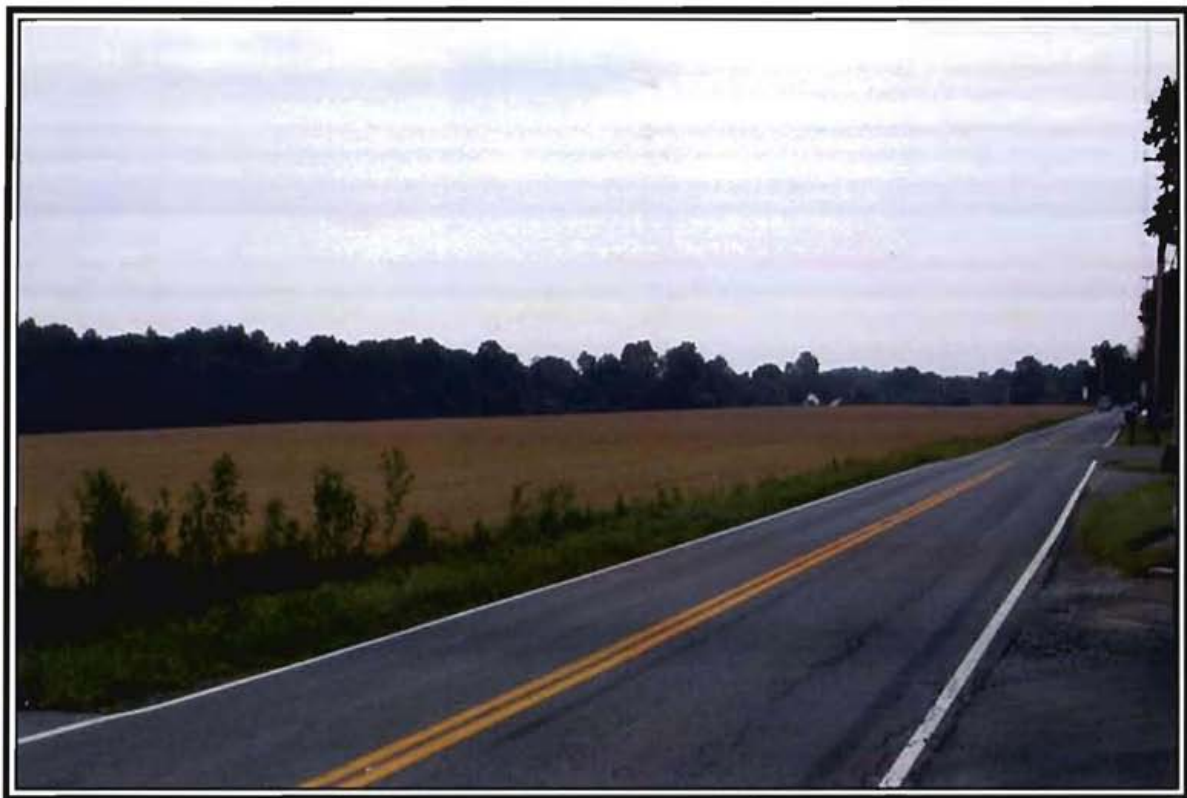
Photograph 3. View of Test Area 3, facing east.

C Stations 51+75 to 54+80	no testing	none	paved driveways; disturbances by landscaping; adjacent to existing roadway shoulder disturbance.
Test Area 3 (Photograph 3) Stations 54+80 to 69+90	29 STPs at 15.0 m intervals	pre-contact - isolates; small artifact scatters; temporary, single to multiple use sites historic - rural domestic artifact scatters	<i>in situ</i> soils of appropriate age; old agricultural field with potential localized modern disturbances; moderately well-drained soils (Mattapex silt loam). no historic documentation of structures; rural land-use throughout historic period.
Test Area 4 Stormwater Management Area (Photograph 4) Stations 69+90 to 76+00	36 STPs at 15.0 m intervals	pre-contact - isolates; small artifact scatters; temporary, single to multiple use sites historic - rural domestic artifact scatters	<i>in situ</i> soils of appropriate age; agricultural field with potential localized modern disturbances; moderately well drained soils (Mattapex and Matapeake silt loams). no historic documentation of structures; rural land-use throughout historic period.

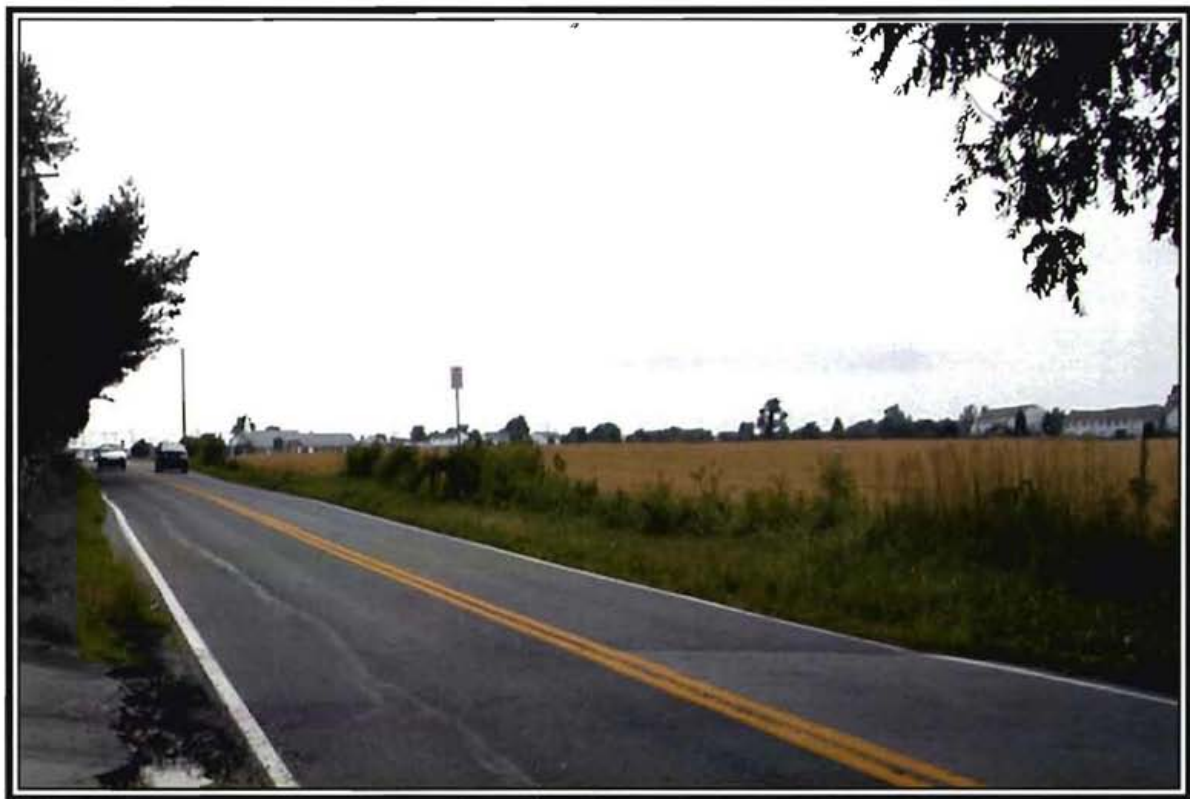
Photograph 4. View of Test Area 4, facing north.

Project APE Segment	Testing Methodology*	Expected Resources	Justification
South Side of School Bell Road (west to east)			
D Stations 17+50 to 31+80	no testing	none	paved driveways and roadway; housing with associated fencing, landscaping, and paving; scalped and graded areas; excavated water retention ditches; adjacent to existing roadway shoulder disturbance.
E Stations 31+80 to 48+00	no testing	none	paved roadway; extensive housing development with associated fencing, landscaping, and paving; excavated water retention ditches; adjacent to existing roadway shoulder disturbance.
Test Area 2 (Photograph 2) Stations 48+00 to 52+80	10 STPs at 15.0 m intervals	pre-contact - isolates; small artifact scatters; temporary, single to multiple use sites historic - rural domestic artifact scatters	<i>in situ</i> soils of appropriate age; agricultural fields with minor plow disturbance; moderately well drained soils (Matapeake silt loam); minor disturbance from existing roadway. no historic documentation of structures; rural land-use throughout historic period.
